“That Sinking Feeling”

Sinkholes and Remediation in Hillsborough County, Florida

Philip J. Erbland, P.E.

Ardaman & Associates, Inc., Tampa

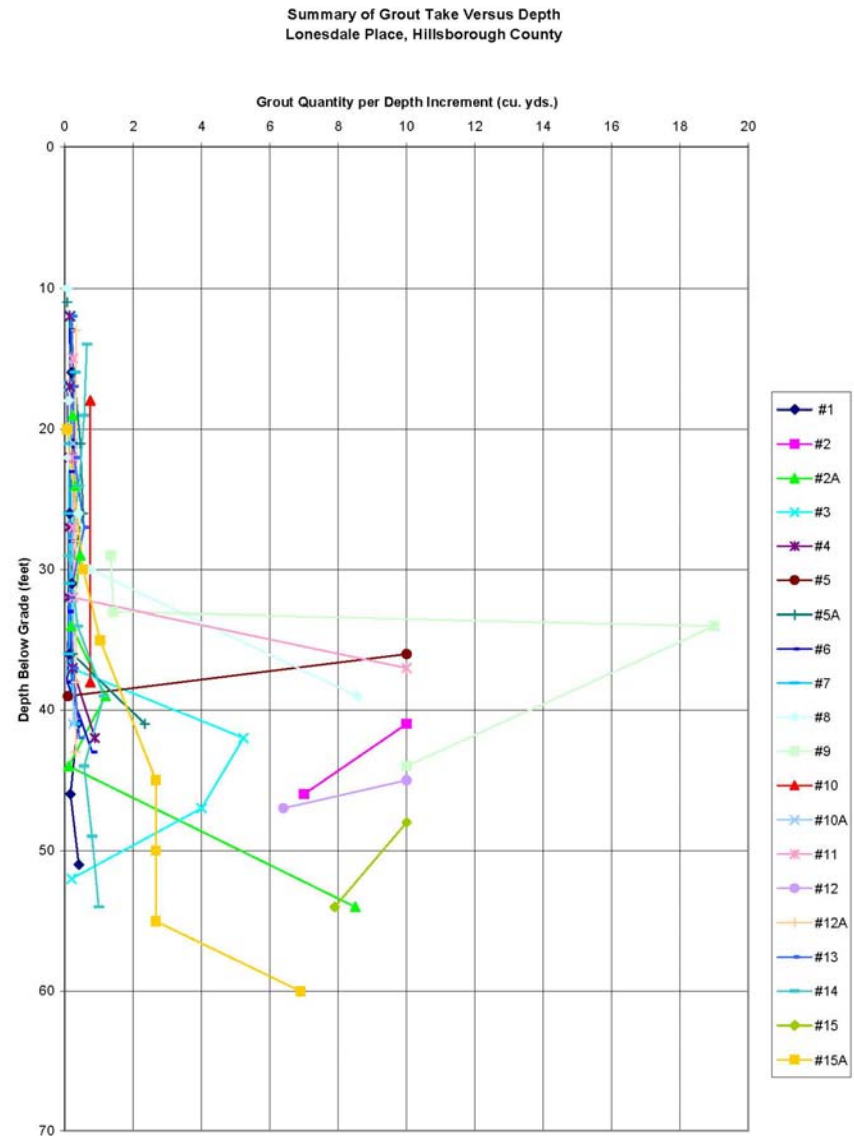
Estimated Grout Distribution versus Depth below Grade

This shows that the grout is
placed mostly above the
limestone

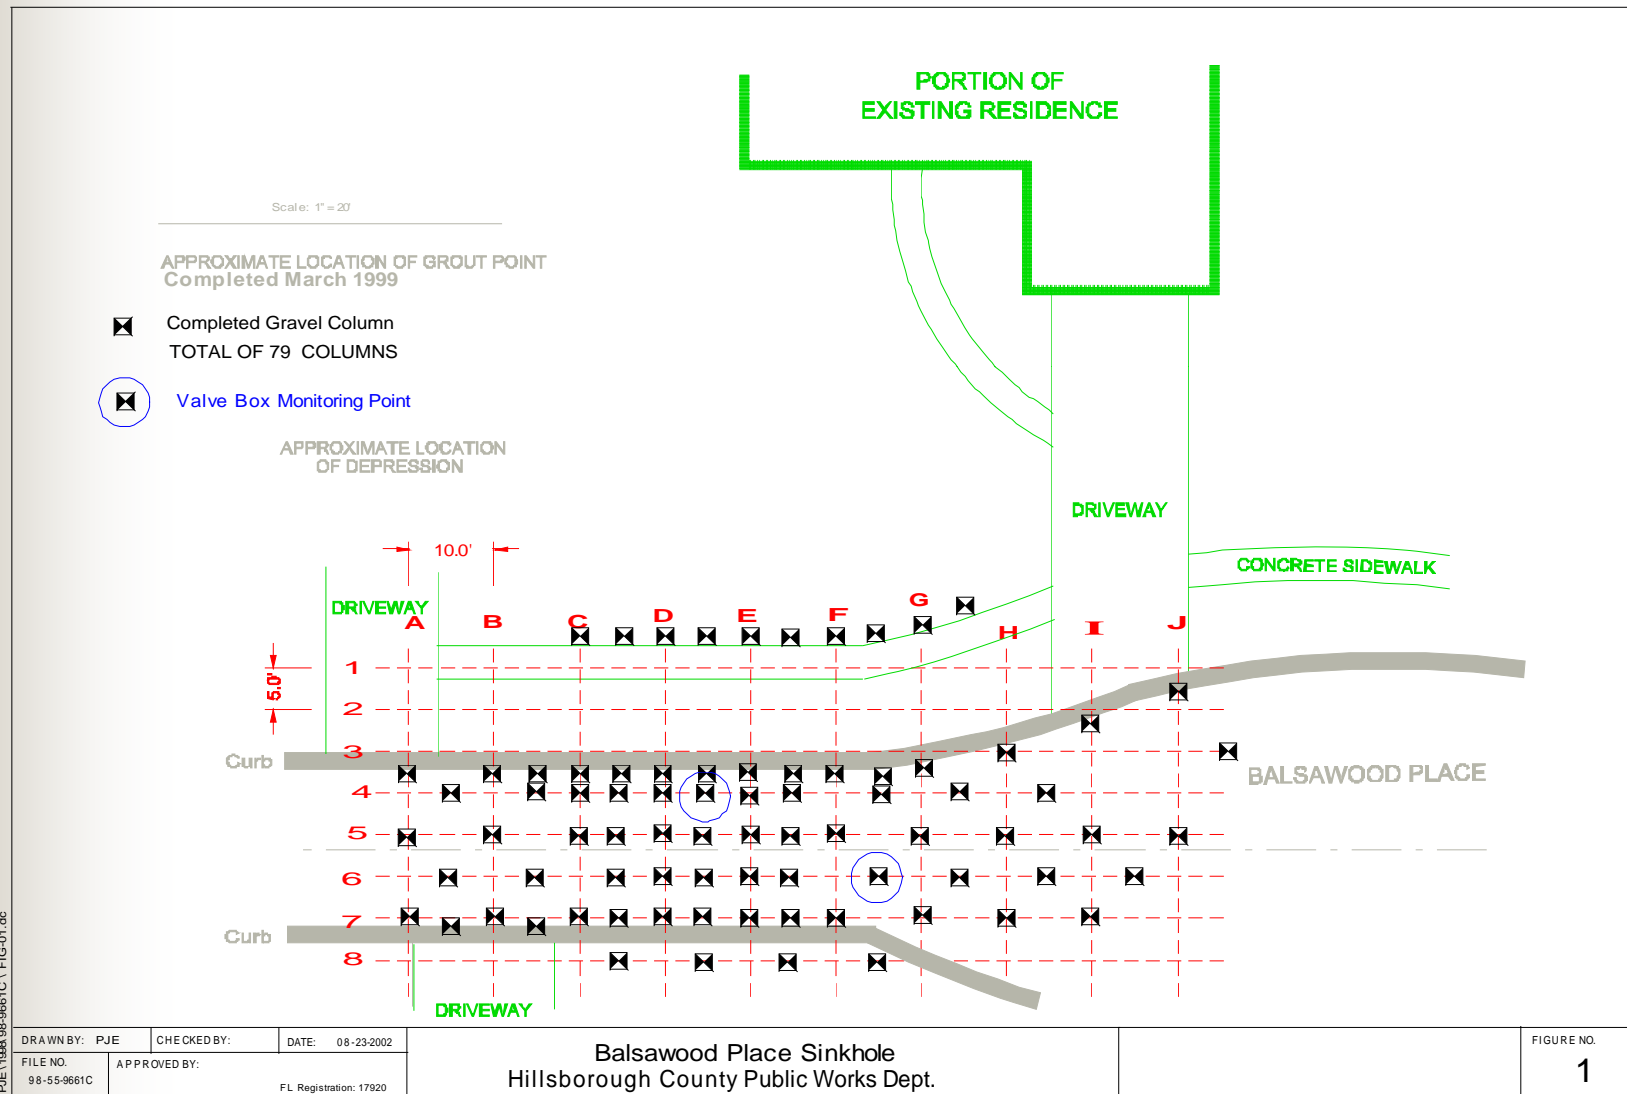
Locations of CSV Gravel Columns

Balsawood Place was grouted in 1999 with 325 cu. yards in 13 grout points 28 to 44 feet deep. However, the area continued to subside. An alternative system was proposed; CSC Gravel Columns.

1. Used #89 Silica Gravel
2. Limited to about 35 feet below grade with the rig
3. Total cost about 1/2 the cost of the previous grouting

The project was completed in March, 1999 with no further subsidence
