# Transportation Data Approach Options Bridge Deck Inspections

Rick Wallace, Southeast Region Manager

# Bridge Inspection Using Airborne Thermal Infrared mapping

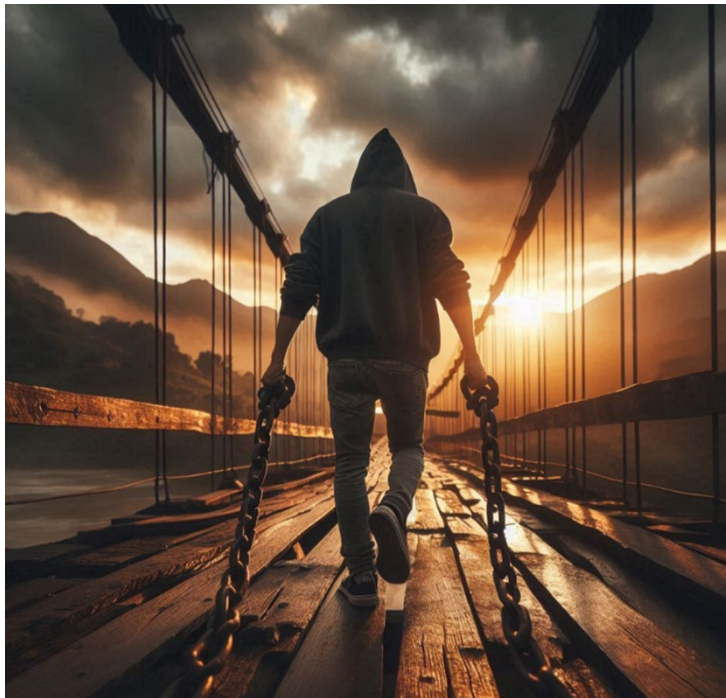
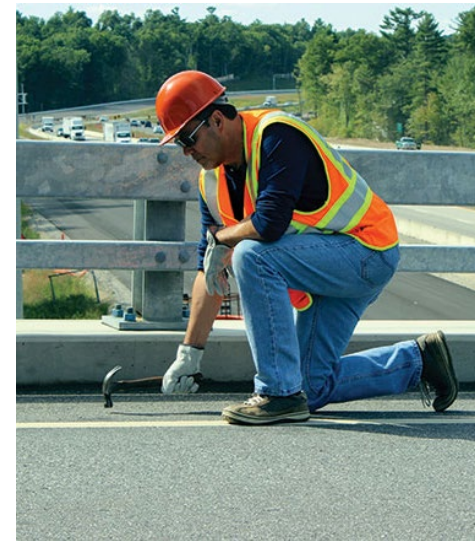
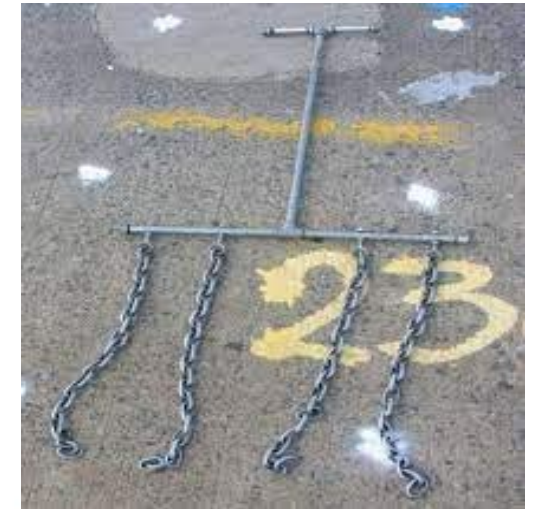
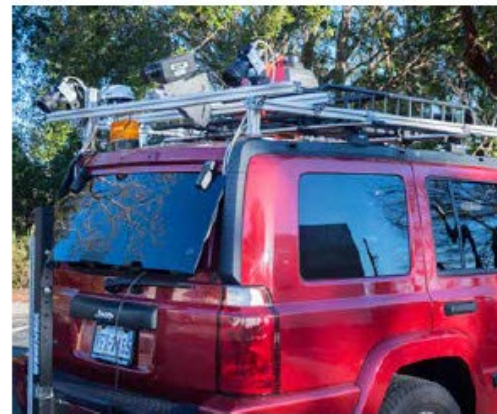
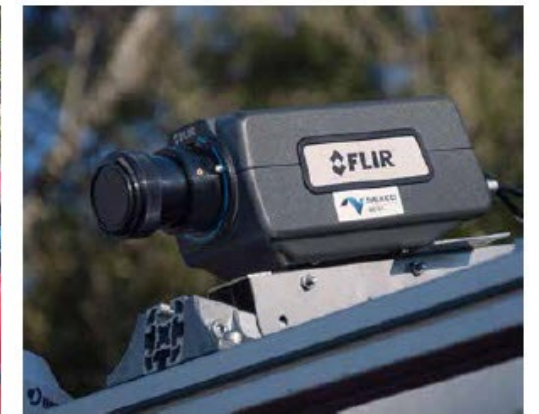
# EXISTING TOOLS

## Nondestructive Technologies (NDTs)

Remote sensing techniques include chain dragging, sounding, impact echo, ultrasonic surface wave, ground-penetrating radar, image-based techniques, and *infrared thermography*.

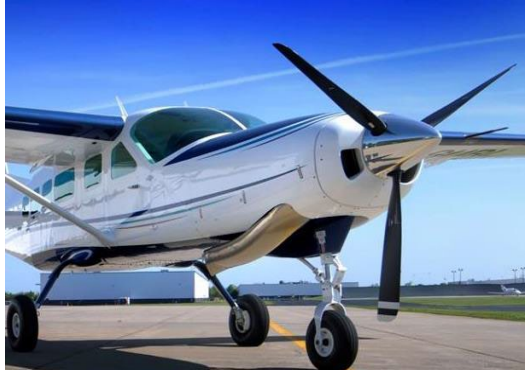
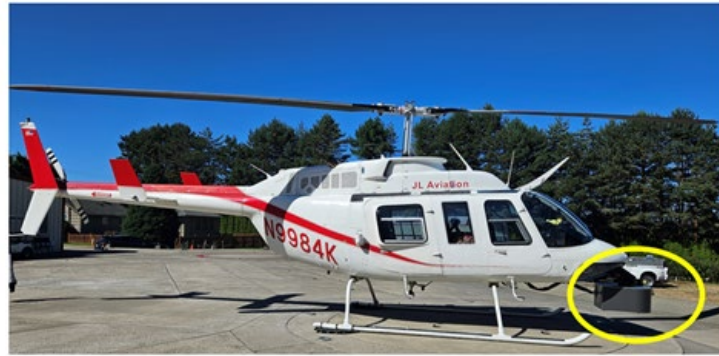
## Fixed wing, low-altitude flights

- 1,000-2,000 ft above mean terrain (AMT)
- 100-130 knots nominal airspeed
- Nominal resolution = 1.5-3.0 inch
- 147 ft width x 118 ft length
- 10 frames per sec
- 80% forward overlap

## 1,000 ft bridge is captured in:

- **≤10 sec**
- 100 frames
- Single flight line
- Turn around as needed (≤5 minutes)

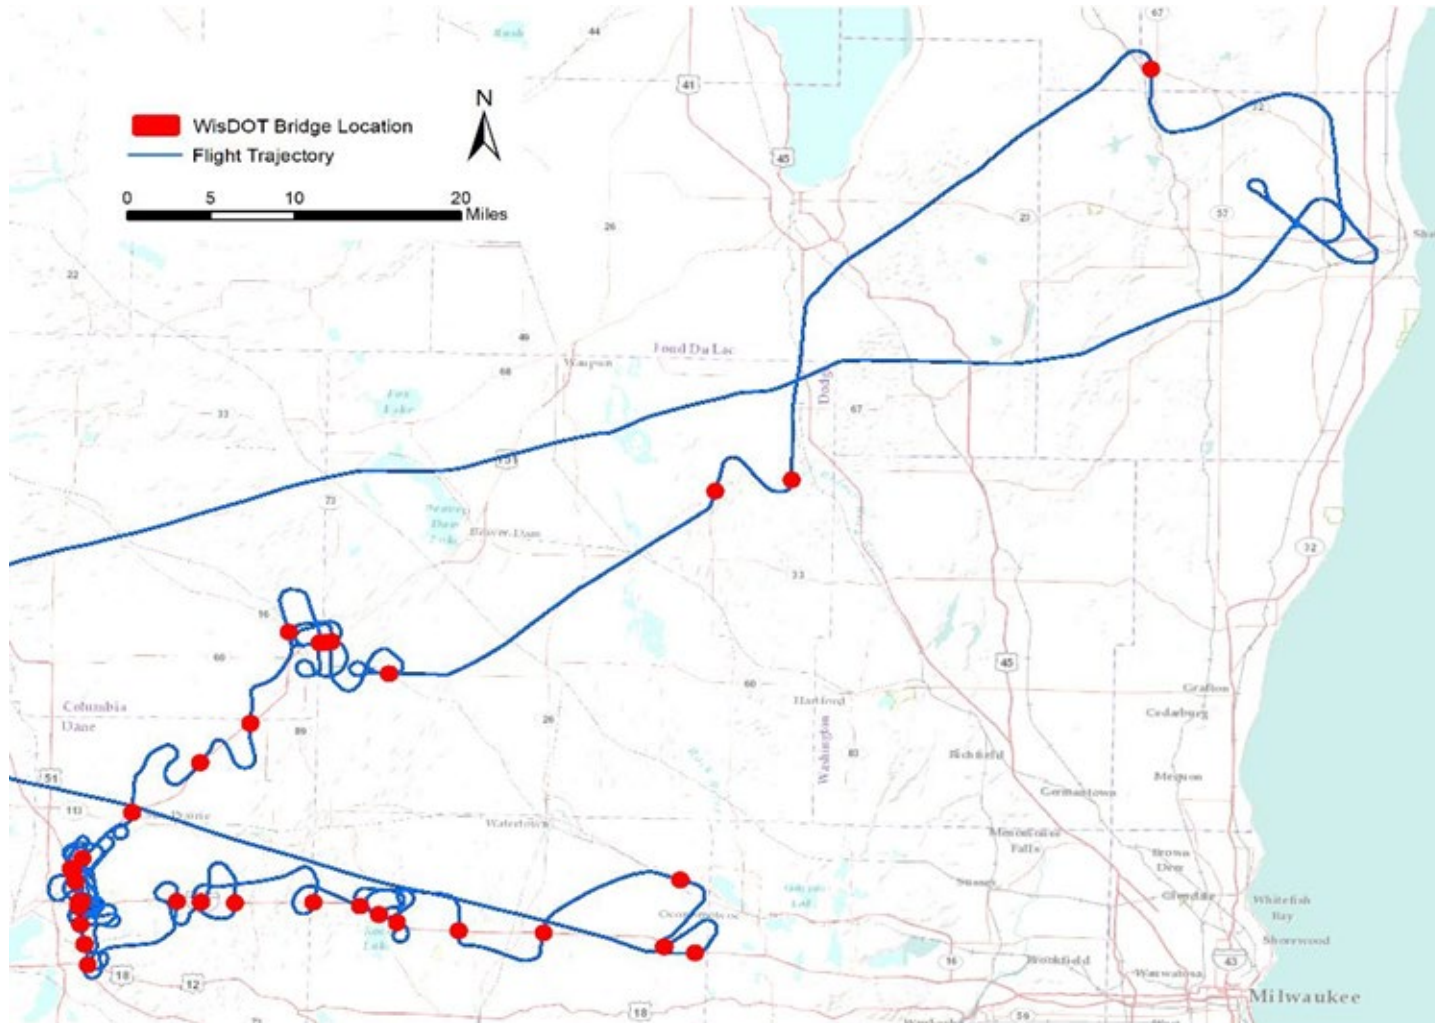
# 40 BRIDGES IN A FEW HOURS

Flight path for surveying 40 bridges in a single mission.

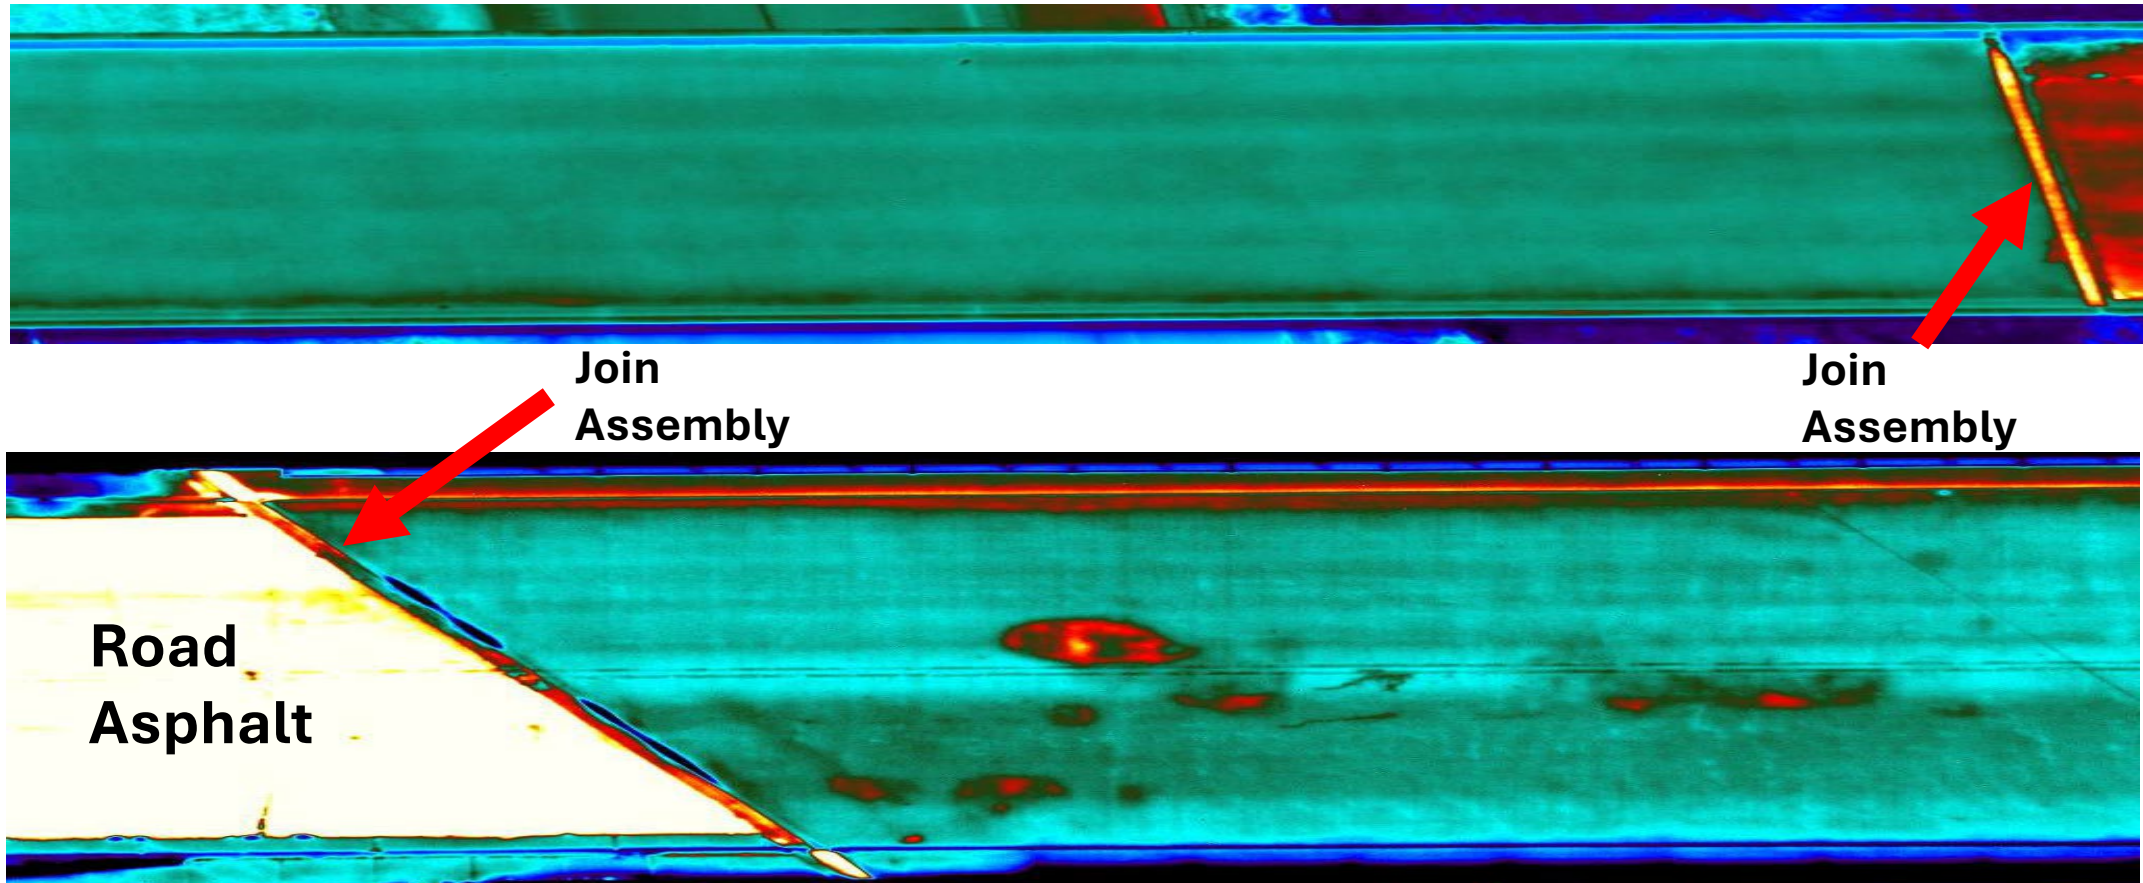
# THERMAL ANOMALIES

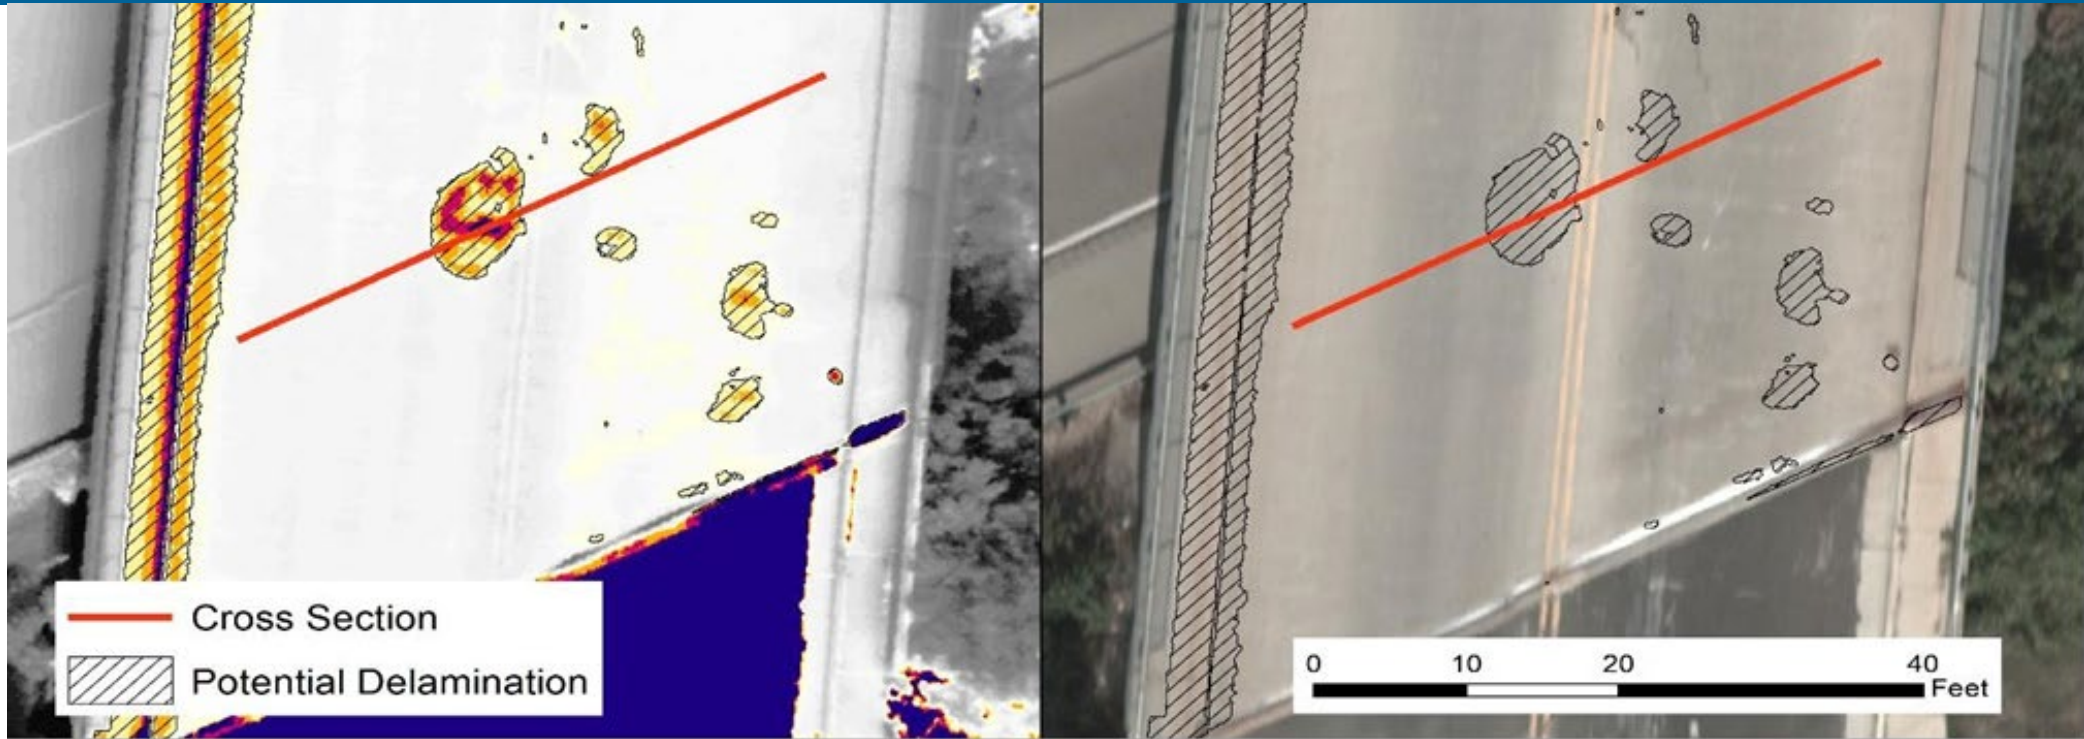
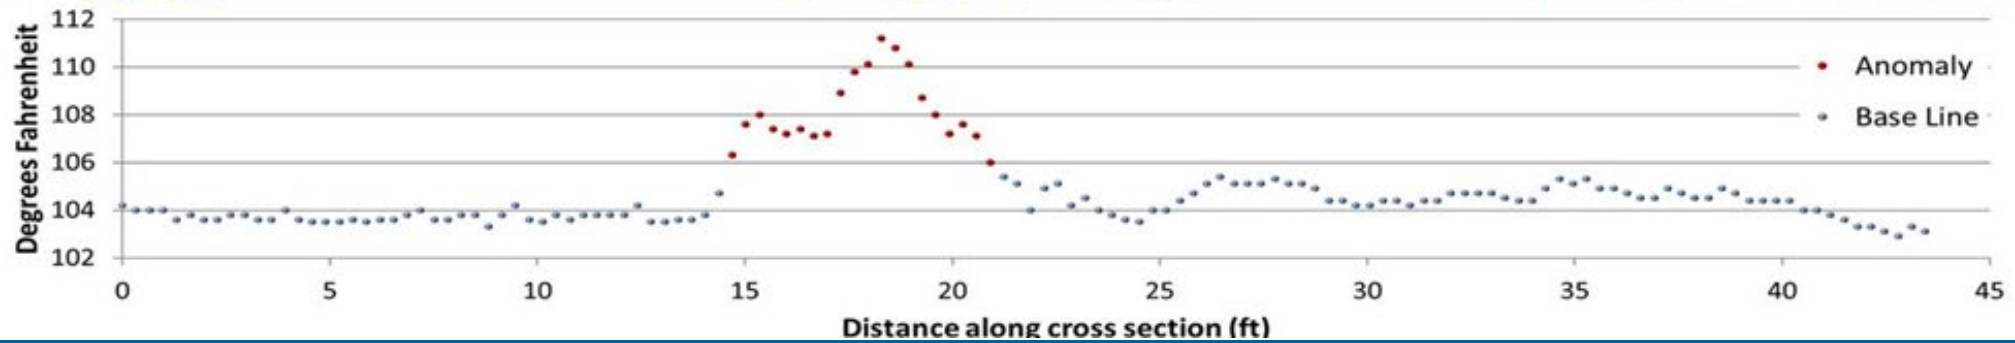
# HOW HOT IS HOT?

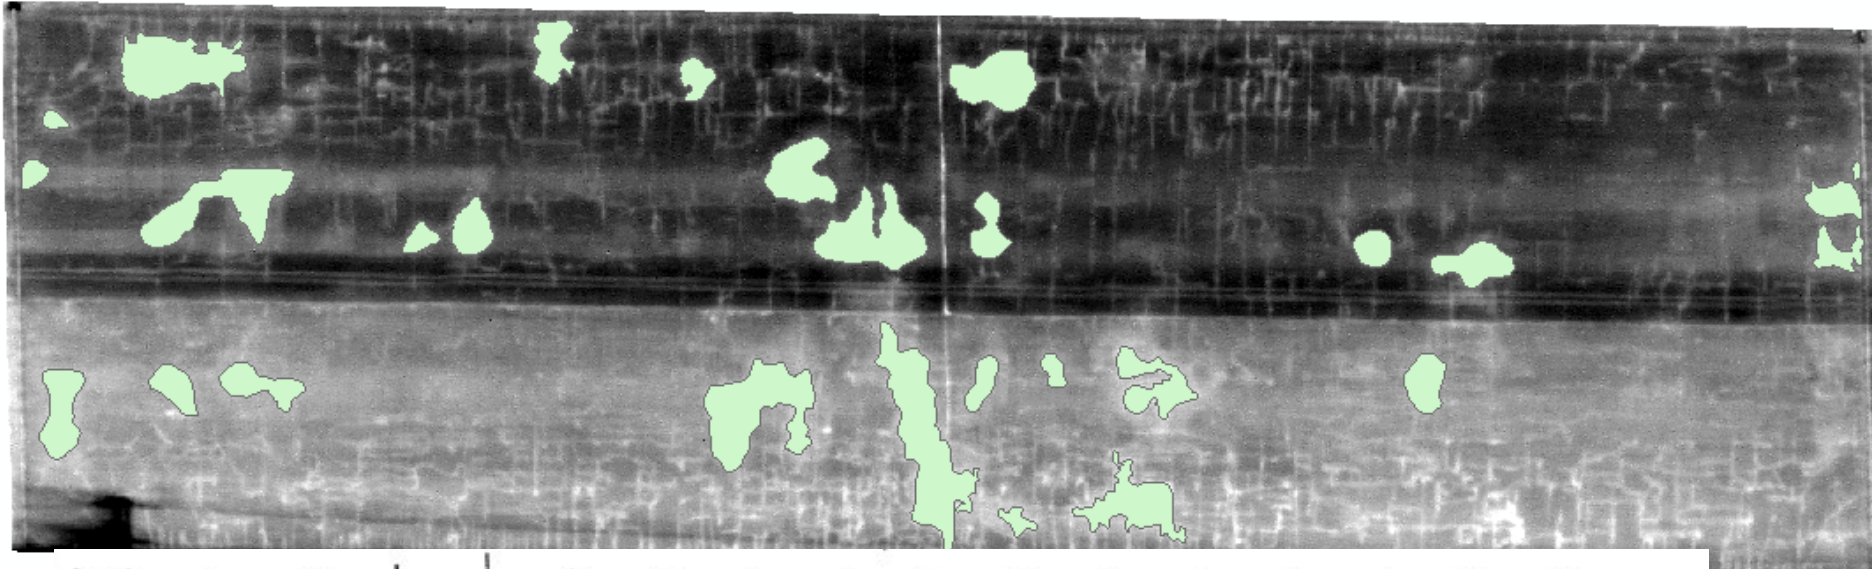
# THERMAL VS. CURRENT METHODS RESULTS

Not detected by chain dragging

Detected by chain dragging and TIR

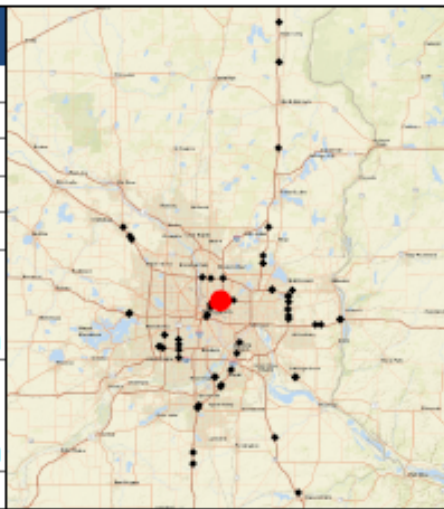
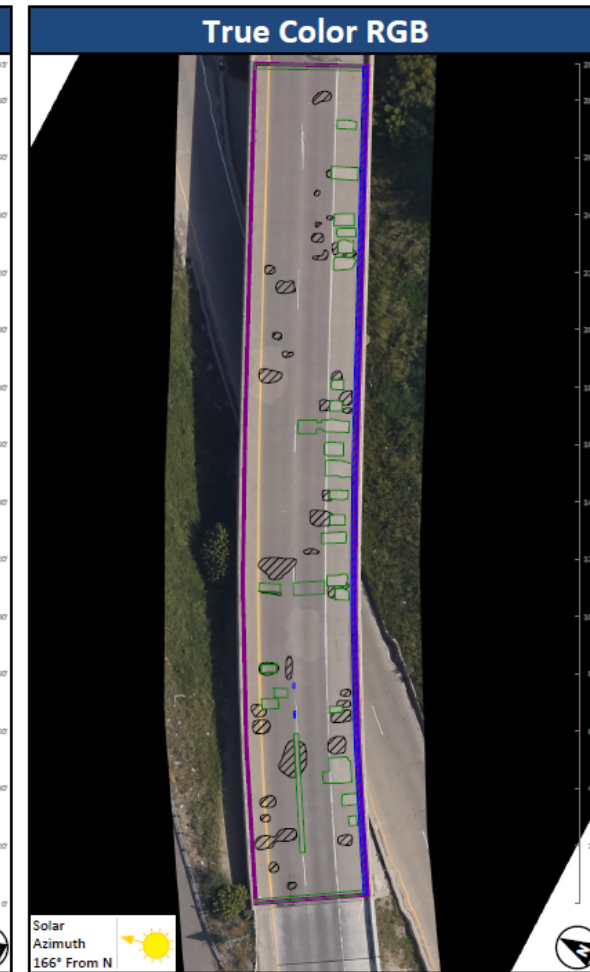
# TECHNICAL REPORT

- Intuitive and user-friendly reports
- Customizable

| Bridge Information | | | |
|---|---|---|---|
| Name 62853 | Acquired 9/14/2023 12:30 PM CDT (-5) | Solar Altitude 47.5° | |
| Bridge Area 11,382.5ft <sup>2</sup> | Delamination Area 649.7ft <sup>2</sup> (5.7%) | PCC patch Area 893.3ft <sup>2</sup> (7.8%) | |

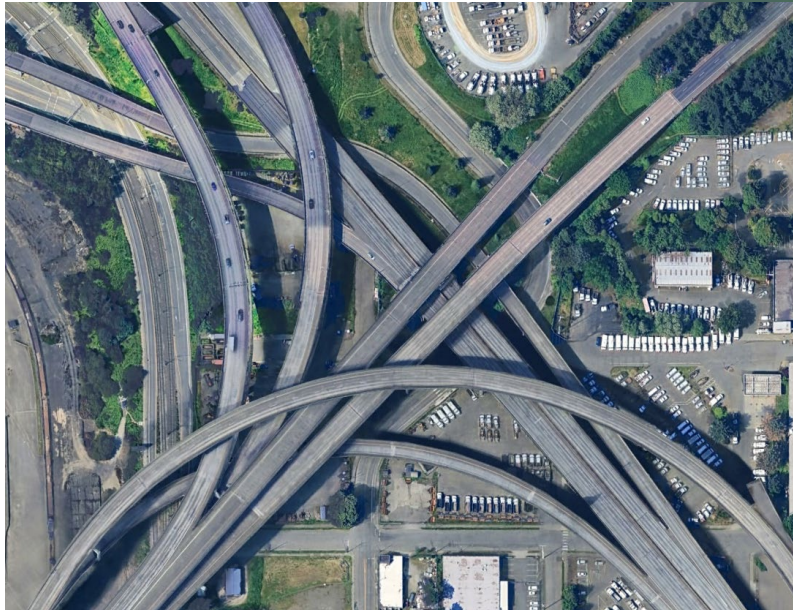
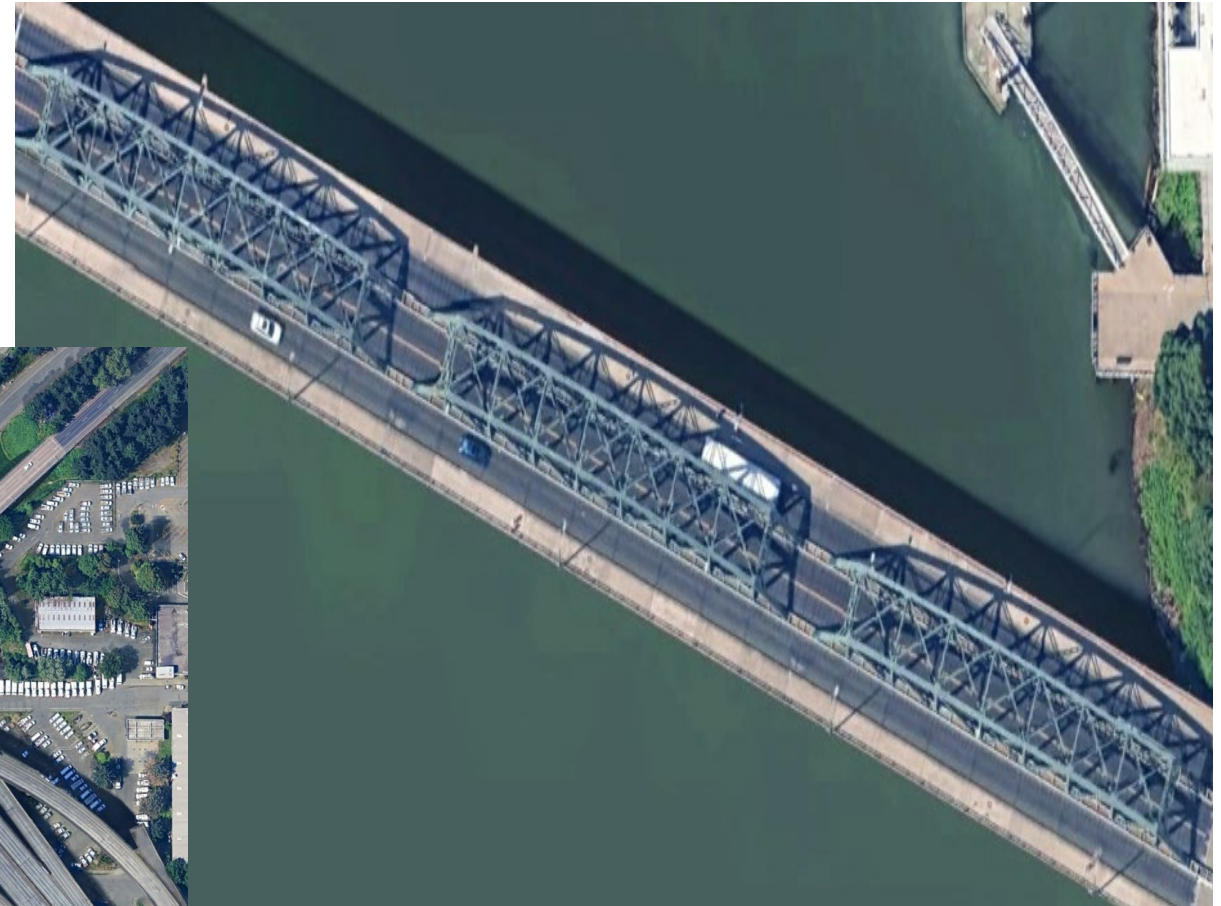
# BRIDGES WE CANNOT DO

- Bridges with Obstacles
  - Trusses
  - Multi-deck bridges
  - Heavy traffic
  - Narrow Terrain

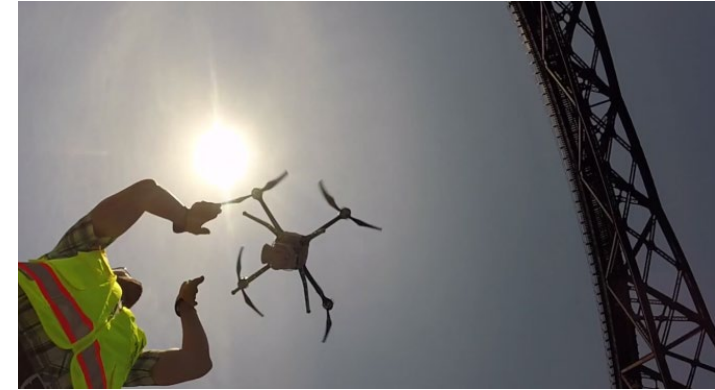
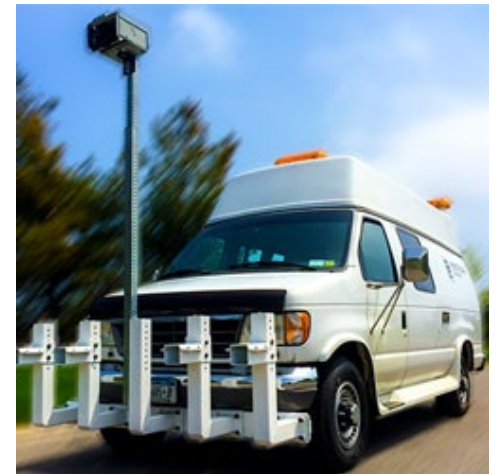
- UAVs solution- Pros
  - Single bridge
  - Similar resolution
  - Additional data
- UAVs solution- Cons
  - On-site requirement
  - Time consuming
  - Multiple passes required
  - Safety
  - Extensive coordinating

- Van-based- Pros
  - Single bridge
  - Higher resolution
- Van-based- Cons
  - Slower than traffic
  - Multiple passes required
  - safety
  - Transition time
  - Lacks automation
  - Lack geospatial reference
